CPED STAFF REPORT

Prepared for the Heritage Preservation Commission
HPC Agenda Item #2
September 13, 2016
BZH-29307

Certificate of Appropriateness	To replace a historic slate roof with a synthetic slate roof in the U of M Greek Letter Chapter House Historic District
---------------------------------------	---

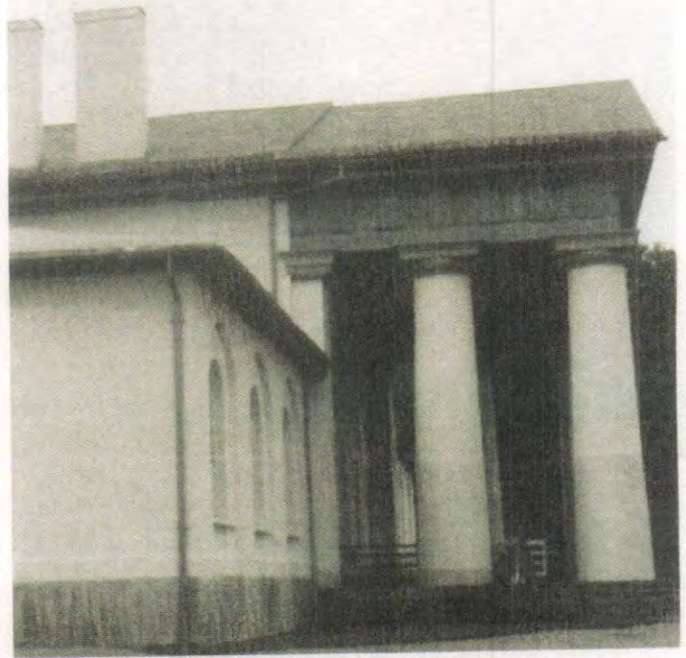
Figure 24. Although slate replacement roofs are expensive, the superiority of materials and craftsmanship will give years of continued service. If amortized over the life of the roof, the replacement cost can be very reasonable. Photograph courtesy of the National Park Service.

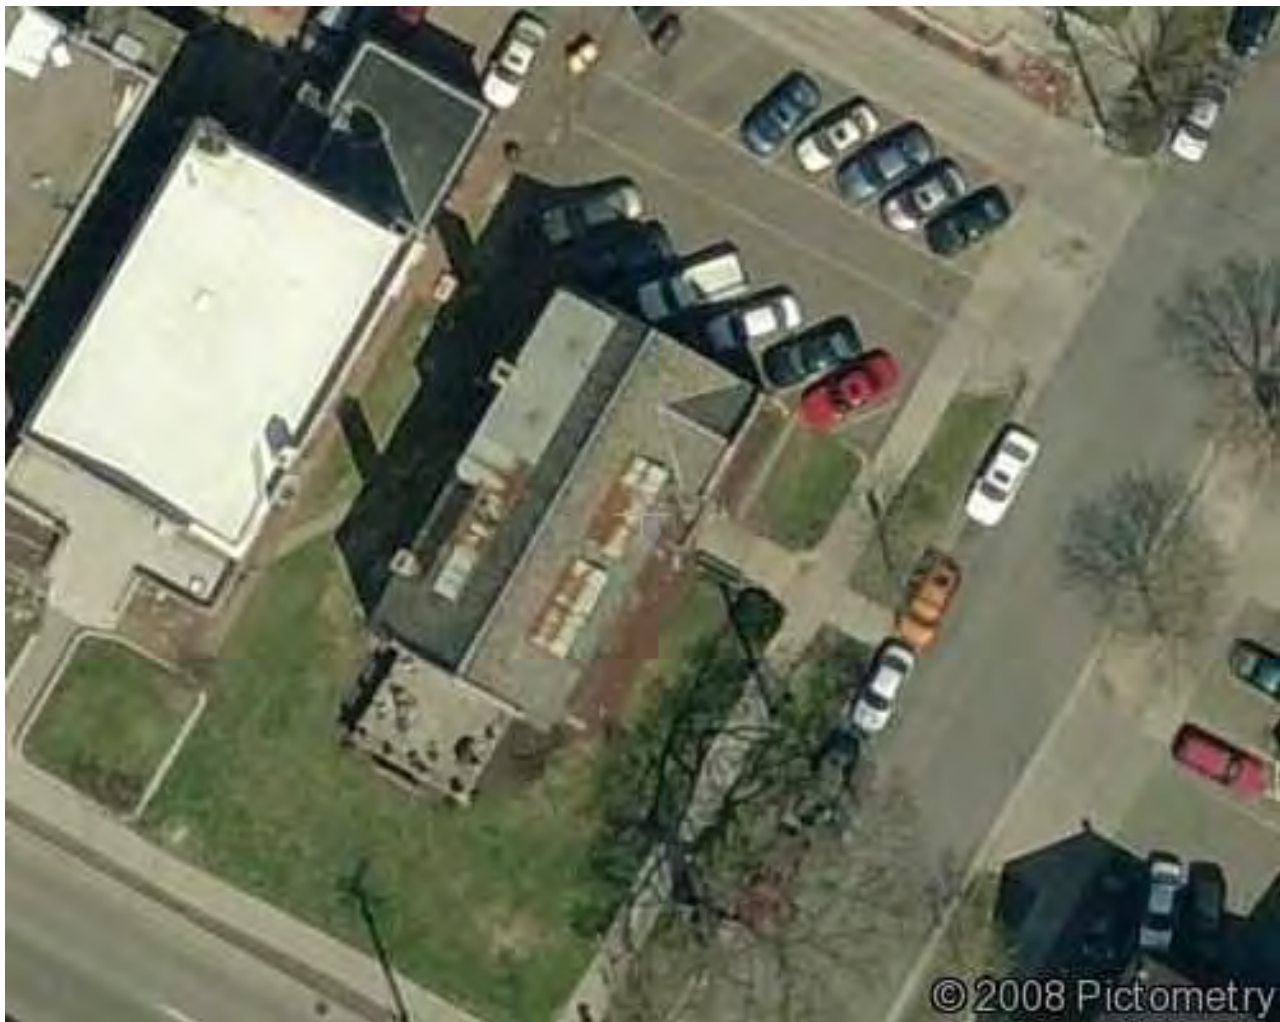
Top View

The following aerial images show different angles of this structure for your reference.

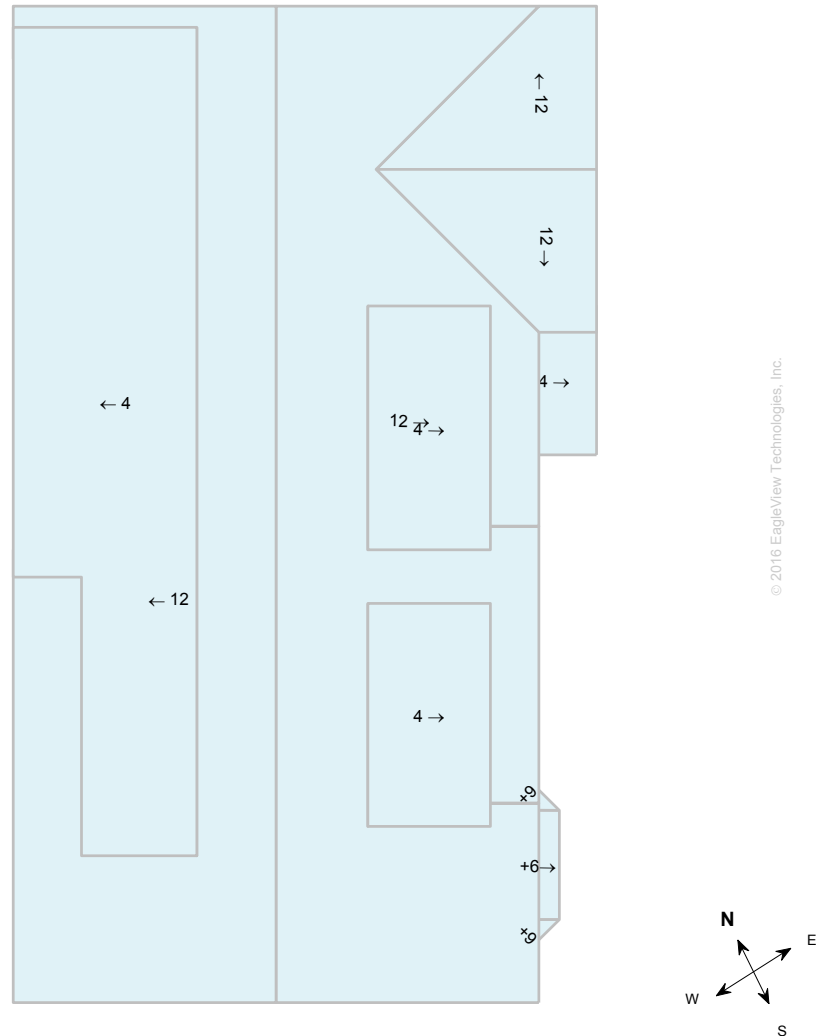
PITCH DIAGRAM

Pitch values are shown in inches per foot, and arrows indicate slope direction. The predominant pitch on this roof is 12/12.

Note: This diagram contains labeled pitches for facet areas larger than 20 square feet. In some cases, pitch labels have been removed for readability. Blue shading indicates a pitch of 3/12 and greater.

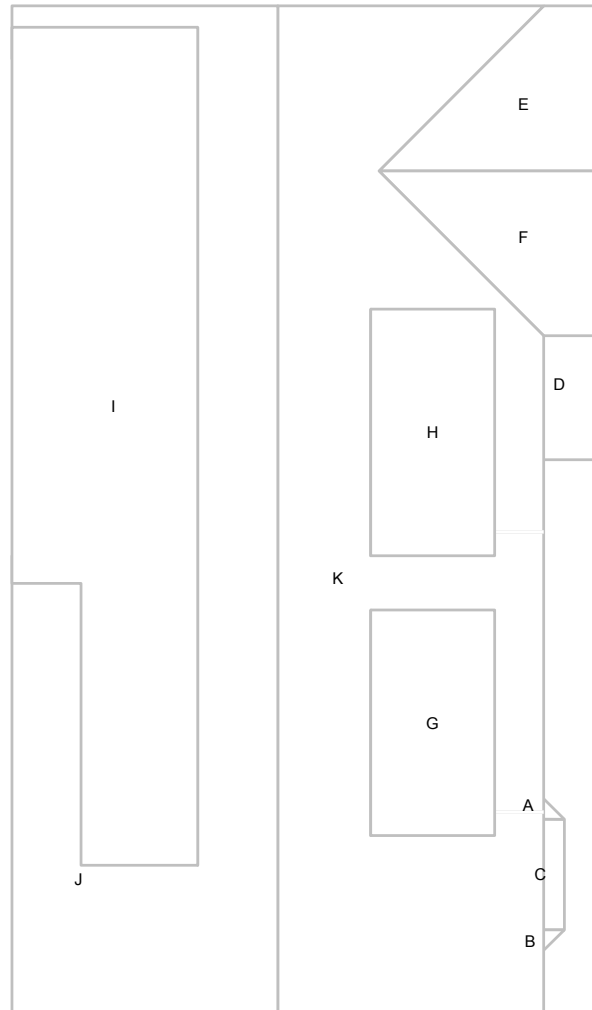
NOTES DIAGRAM

Roof facets are labeled from smallest to largest (A to Z) for easy reference.

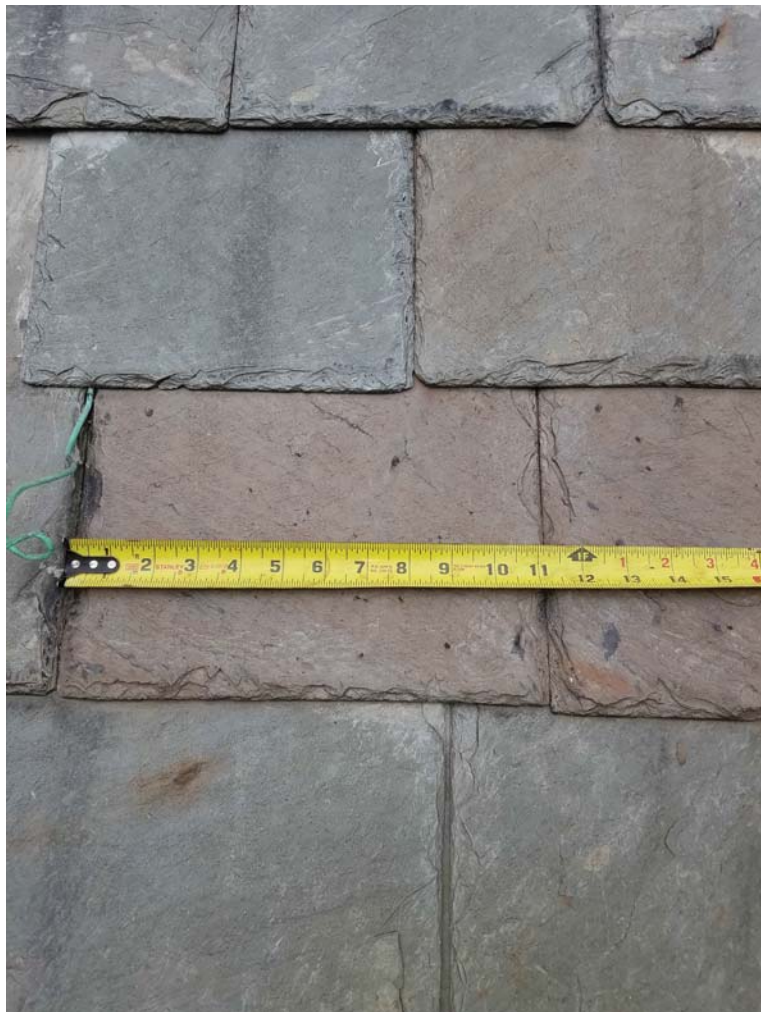
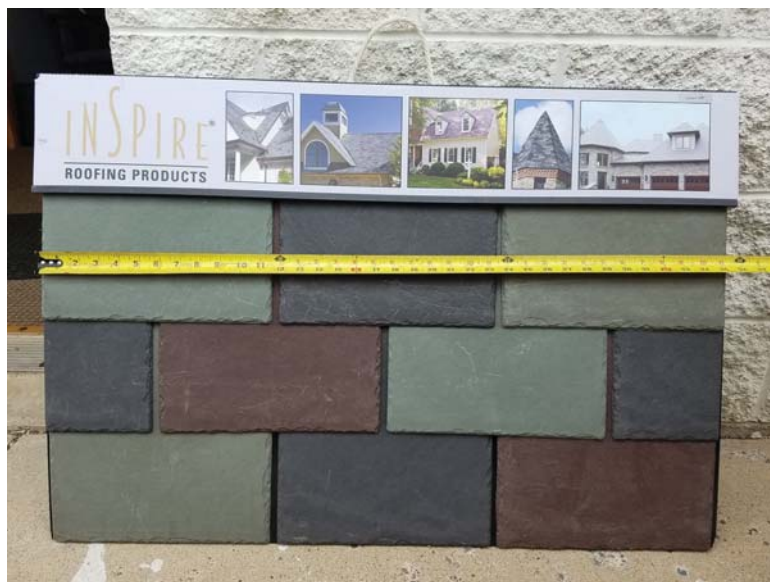
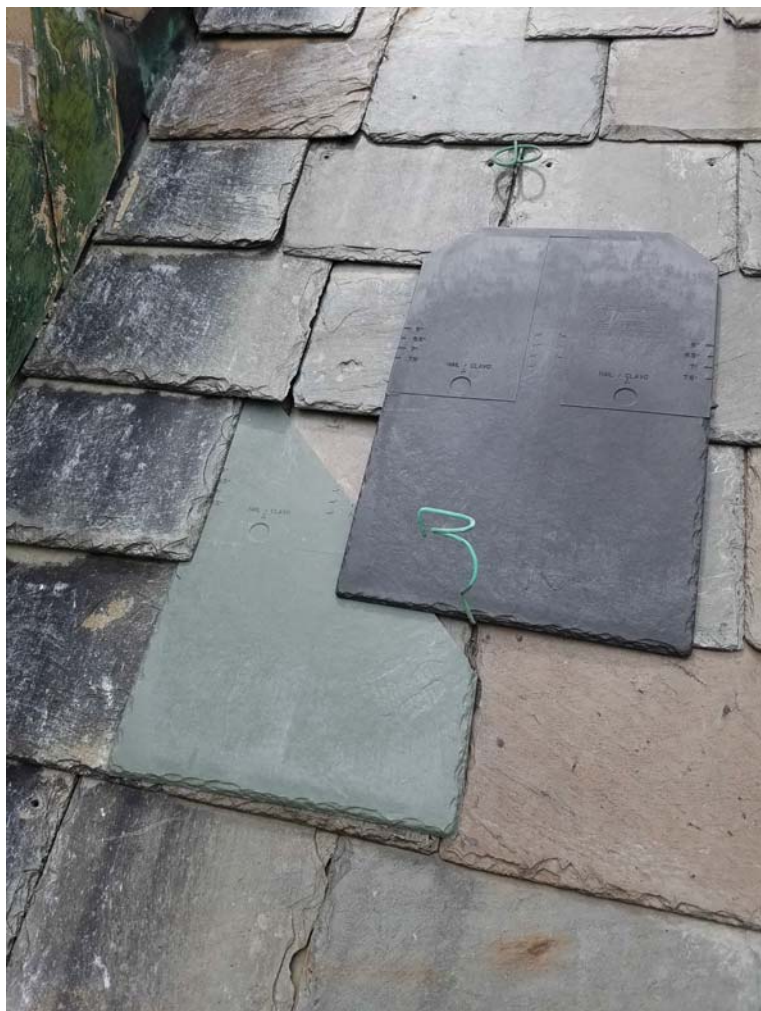
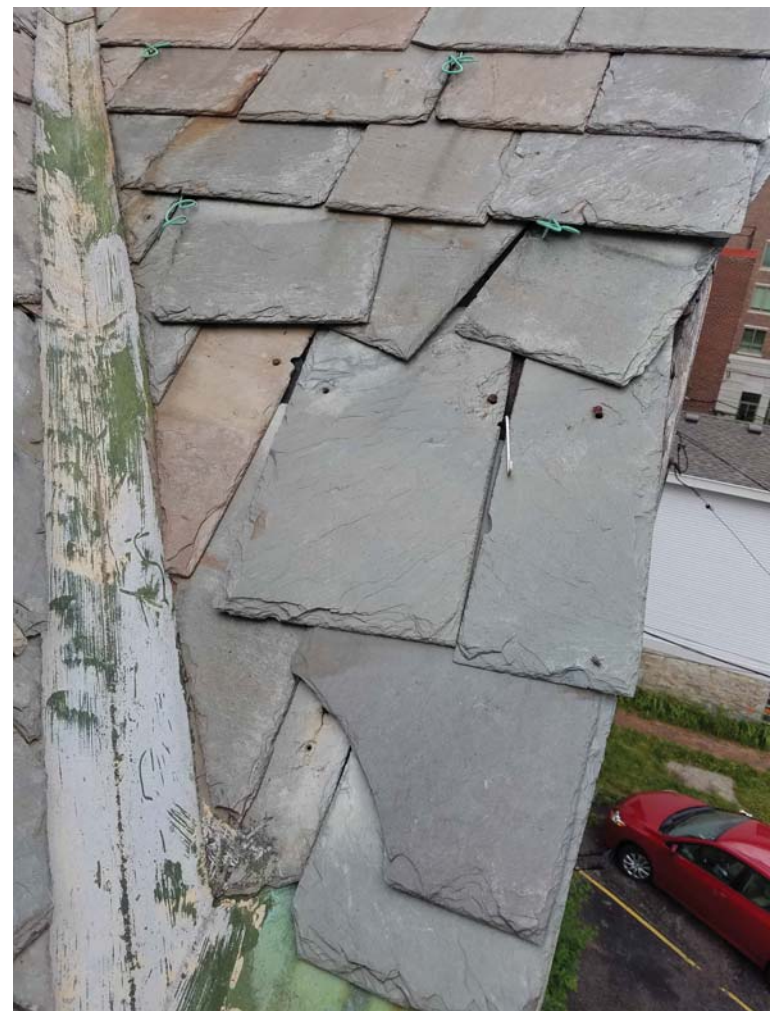
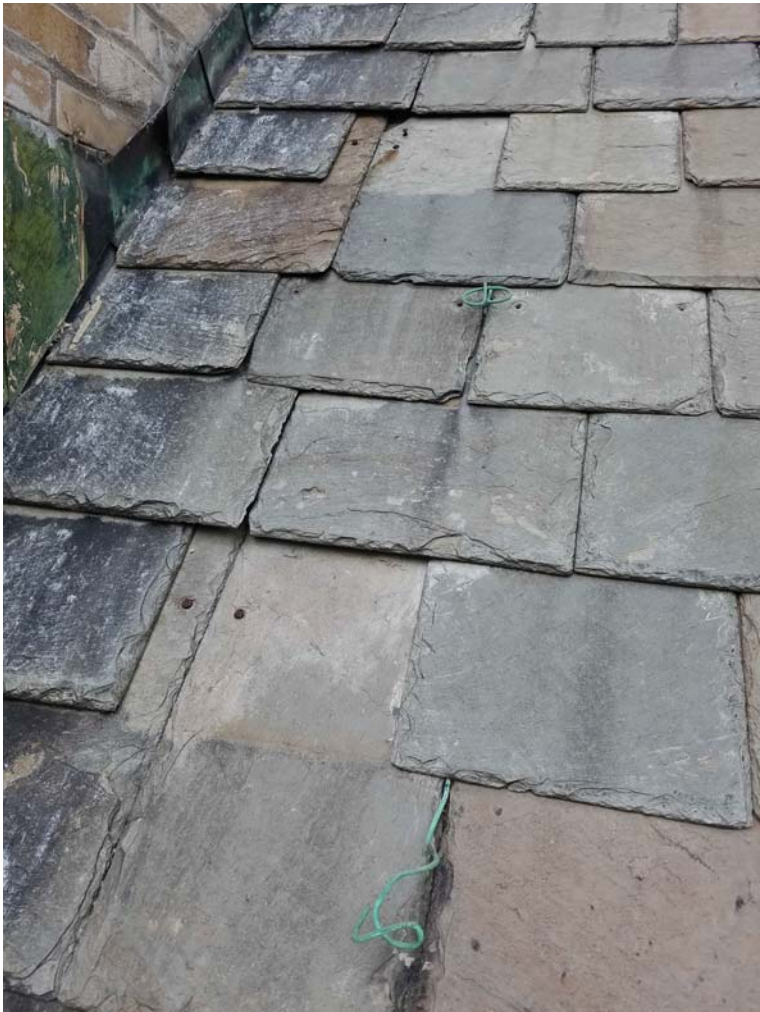
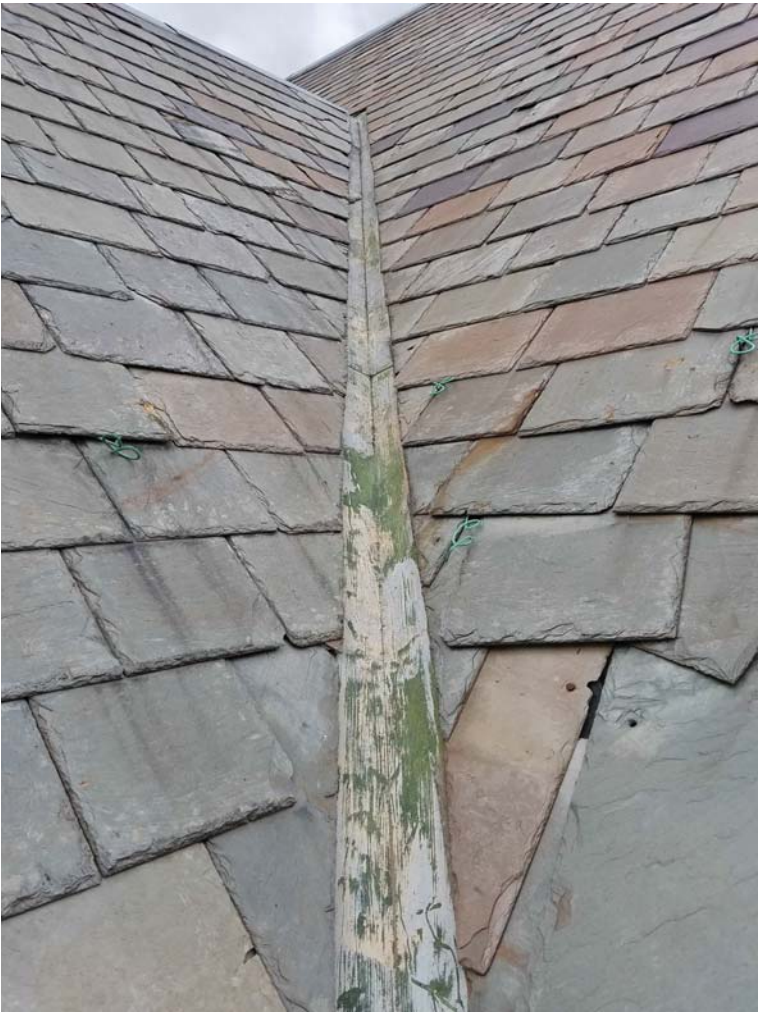
Removal of the existing roof is necessary due to substantial damage to the tiles caused by age and exposure to elements such as rain, wind, snow, ice, UV rays, algae, and pollutants. The current slate roof is 91 years old and original to the structure, built in 1925. The slate has become extremely brittle.

Much of the existing slate tile is cracked, broken, or missing entirely. This creates a hazardous situation in which falling tile could cause damage to persons or property. Many of the fasteners are exposed to the elements, which is causing the fasteners to degrade through rusting and will cause further damage to the tiles that remain. In addition to the condition of the tile, the existing roof is leaking.

The flashings that were installed at the roof valleys, chimneys, and dormers have failed. This failure of the roof membrane is allowing water to penetrate the decking below the tile into the attic and ultimately into the living facilities. The large and material amount of damage across the entire roof system is making it impossible to repair the existing slate tiles.

We have included photographic evidence proving that the majority of the roof is in extremely poor conditions. We have also included guidelines to help decide when to replace a roof. These guidelines are presented in "Preservation Briefs" from the US Department of the Interior, National Park Service, Cultural Resources, and Heritage Preservation Services.

The roof membrane in its entirety must be replaced. If only specific areas are repaired, the remaining tile will continue to deteriorate and cause continued liability issues for the building's owner, and the same process of repair would need to be repeated year after year until the entire roof is eventually replaced. It is unlikely that we would be able to remove and replace the existing tiles without causing further damage in the case of repair. In any areas in which we would repair the existing tiles, we would need to apply an ice and water barrier to meet building code requirements. Meeting the requirements of the building code necessitates removal of the existing slate tile roof, repairing the damaged roof and fulfilling the requirements of the building code.
